POWERVILLE DAM

NJ 00174

6 PHASE 1 INSPECTION REPORT
NATIONAL DAM SAFETY PROGRAM.

Name of Dam: Powerville Dam
Identification No.: Federal ID No. NJ00174
State Located: New Jersey
County Located: Morris
Stream: Rockaway River
River Basin: Passaic
Date of Inspection: May 14, 1979

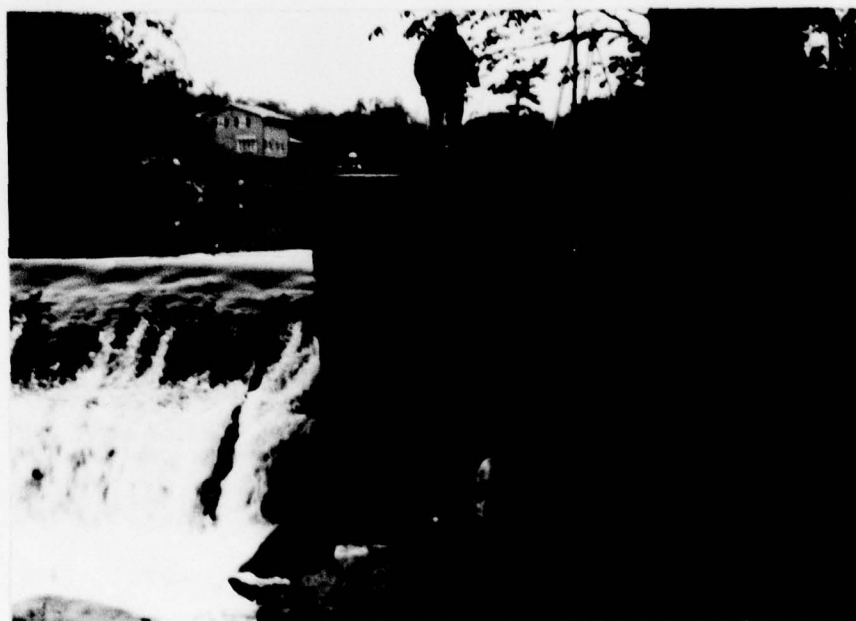
a. Dam. There is erosion and cracking of the concrete abutment wingwall and undermining of the downstream end of the concrete wingwall at the east end of the dam. The visible portions of the concrete spillway crest are deteriorated with large aggregate exposed. The wingwalls adjacent to the gate structure on the west end of the dam are also cracked and deteriorated. Detailed inspection of the spillway could not be accomplished because of the flow over the spillway.

DOWNSTREAM SIDE OF EAST ABUTMENT

(2) Design and supervise repairs to the undermined concrete of the east spillway abutment and to the concrete in the dam spillway and wing walls.

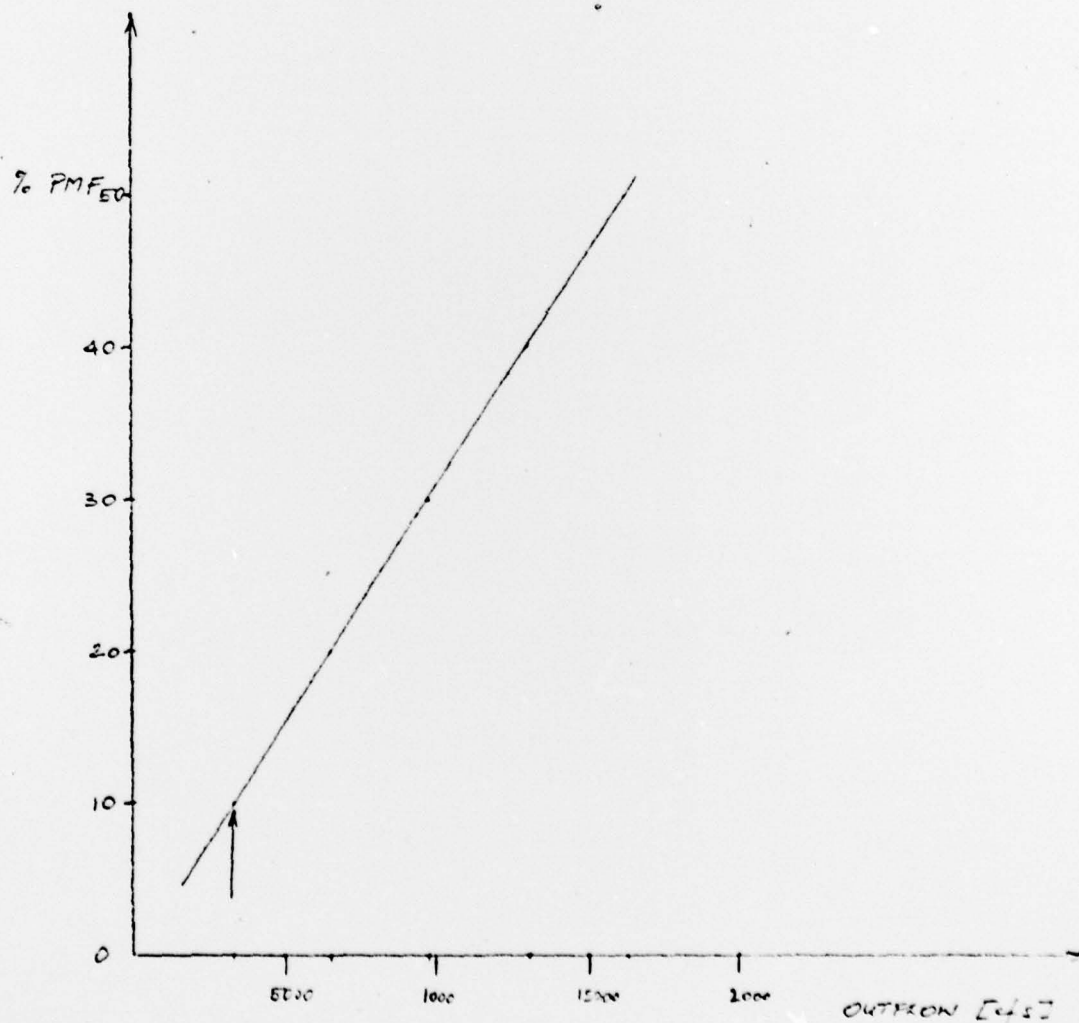
OVERTOPPING POTENTIAL

DAM OVERTOPS AT APPROX EL. 495.2 WITH $Q = 3246 \text{ cfs}$
 \therefore DAM CAN PASS 10% OF PMF
